MINING INDUSTRY

Root Cause Failure Analysis Solves Bearing Problem

- **Application** = Ventilation Fan
- **Motor Type** = AC Induction
- **Manufacturer** = Toshiba
- **HP** = 200
- **Voltage** = 575
- **RPM** = 1800
- **Enclosure** = TEAO

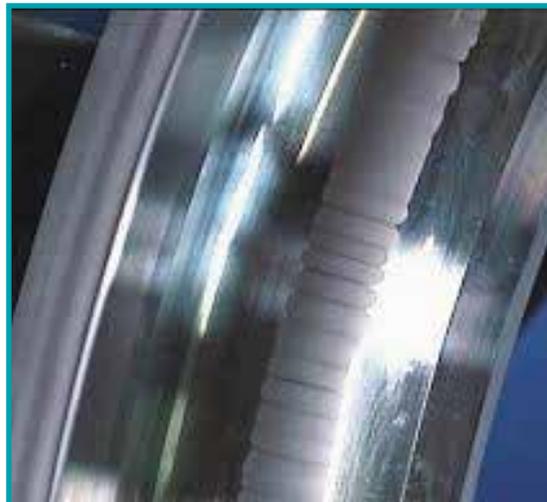
IPS technicians conducted a root cause failure analysis on one of the failed motors, and determined that the failure was due to electrical currents passing through the bearings. It turns out the customer had recently started using adjustable speed drives on some of their fan motors, which was determined to be the source for the electrical currents. IPS recommended the following upgrades when repairing the motor:

Electric shaft current can lead to bearing failure due to the formation of fluting in bearing raceways.

- Replace old bearings with insulated bearings
- Install shaft grounding brush in the motor

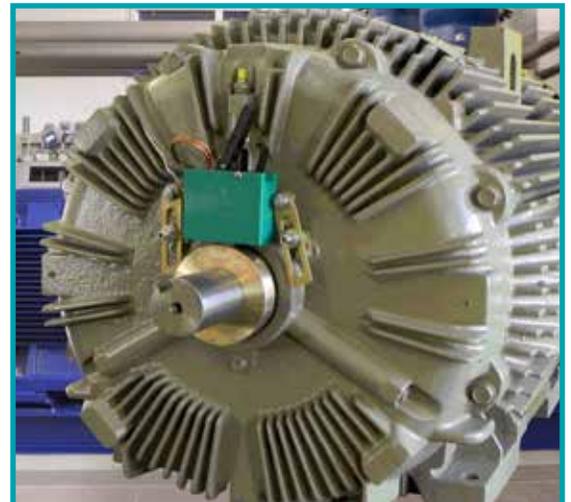
Shaft grounding brushes provide electrical contact to the motor shaft to reduce or eliminate induced shaft currents.
