TCO CASE STUDY

Wind Power Industry

Connection Ring Solution Reduces Downtime and Maintenance Costs

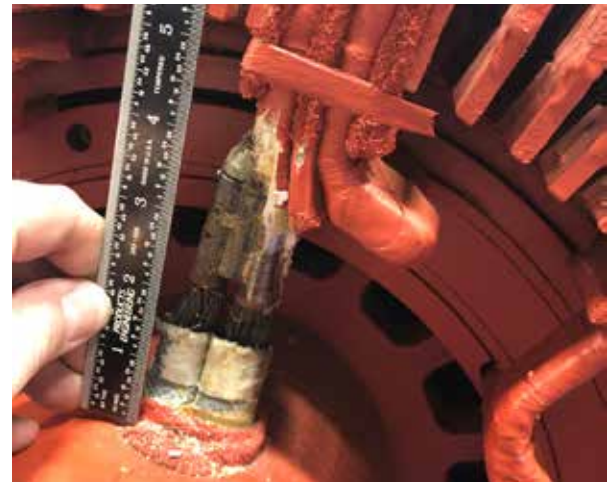
A wind farm was experiencing premature failures on their wind turbine generators. After an initial inspection of a particular generator, it was determined that the rotor connection had failed prematurely. Wind turbines that utilize DFIG generators (wound rotors) have a 61% failure rate in the rotor connection due to the inability to accommodate centrifugal expansion of the rotor winding/banding during operation.

Centrifugal expansion is a common problem.

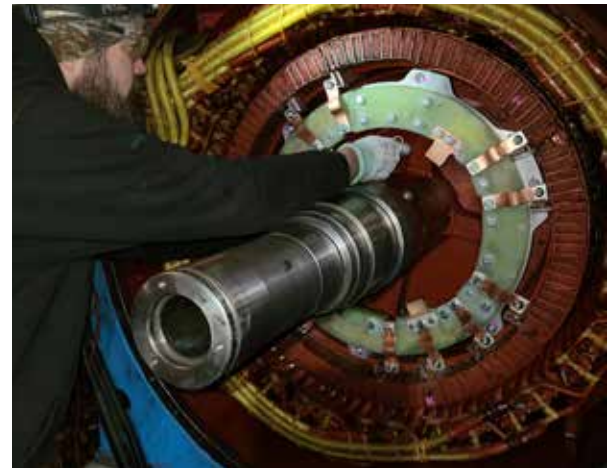
The IPS engineered upgraded rotor connection is designed to accommodate stretching connectors without fatigue.

IPS recommended installing our patent pending engineered upgraded rotor connection. This upgraded rotor connection accounts for the centrifugal expansion of the rotor winding/banding during operation preventing low cycle fatigue and eliminating main lead failure modes. The upgraded rotor connection life expectancy is 2+ times longer than the OEM, but also minimizes downtime and maintenance costs since the upgrade can be performed up-tower.

Due to the IPS engineered upgraded rotor connection solution, the IPS Wind Team was able to repair the failed generator up-tower and eliminate crane and replacement generator costs. After installation and repair costs we saved this customer an estimated \$90,000 - \$120,000.
