# PAPER MANUFACTURING

*Quality Machining Eliminates Unplanned Downtime*

- **Application** = Pump
- **Motor Type** = AC Induction
- **Manufacturer** = Baldor
- **HP** = 400
- **Voltage** = 4160
- **RPM** = 3600
- **Frame** = G5010S
- **Enclosure** = TEFC

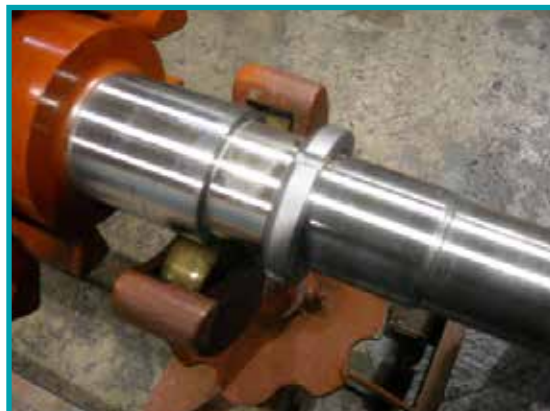
*Bent drive shaft resulted in bearing preloading, overheating and failure*

IPS properly machined and tested all components and returned the motor to the paper mill. The motor is currently back in operation and running with no issues.

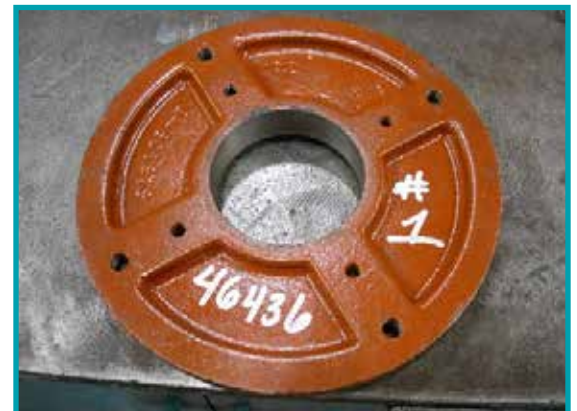
- The drive shaft journal was found to be improperly machined, causing misalignment. For a 6313 bearing, maximum tolerance for the shaft journal is 2.5592 inches. The drive shaft journal was measuring 2.5601 inches.
- Also, maximum tolerance for the bearing housing is 5.5128 inches. The drive end bearing housing measured 5.5131 inches. This improper machining also caused misalignment.
- The drive shaft was found to be bent, causing bearing preloading, overheating and failure, which was compiled by overgreasing of the bearings due to not understanding the root cause issue.

*Improperly machined drive end bearing housing caused misalignment*
