MINING INDUSTRY

Root Cause Failure Analysis Solves Bearing Problem

- **Application** = Ventilation Fan
- **Motor Type** = AC Induction
- **Manufacturer** = Toshiba
- **HP** = 200
- **Voltage** = 575
- **RPM** = 1800
- **Enclosure** = TEAO

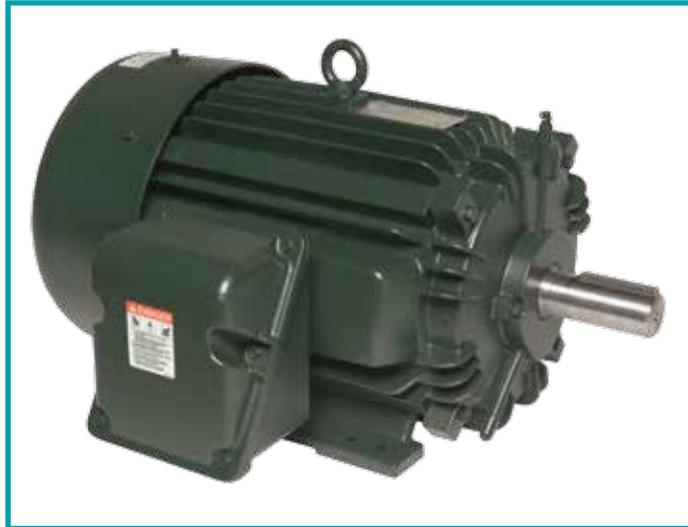
A gold mine in Ontario, Canada has over 50 ventilation fan motors ranging from 100 HP to 800 HP. Many of these motors were experiencing premature bearing failures. Depending on the fan motor, unplanned plant downtime costs were as high as \$60,000 per hour.

IPS technicians conducted a root cause failure analysis on one of the failed motors, and determined that the failure was due to electrical currents passing through the bearings. It turns out the customer had recently started using adjustable speed drives on some of their fan motors, which was determined to be the source for the electrical currents. IPS recommended the following upgrades when repairing the motor:

- Replace old bearings with insulated bearings
- Install shaft grounding brush in the motor
