TCO CASE STUDY

Powerseal Premium Rewind Improves Motor Reliability

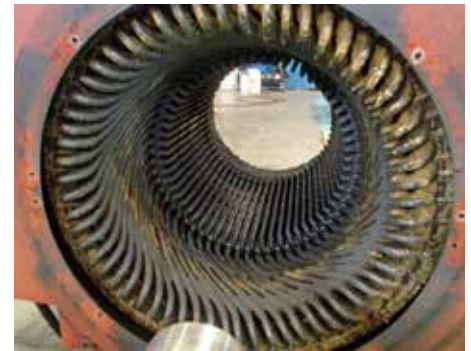
A Midwest coal-fired power plant motor experienced a winding failure caused by high thermal stress from a bearing failure. To prevent future winding failures, the stator was rewound with IPS's PowerSeal premium electrical insulation system. After three years, the motor experienced damage to both bearings. IPS performed a root cause failure analysis and determined clogged air filters were preventing proper airflow into the motor, creating a vacuum pressure and sucking oil out of both bearing housings into the stator. Every time more oil was added to either bearing, it would get sucked out and deposited onto the windings resulting in both sleeve bearings overheating from lack of lubrication.

Before: PowerSeal windings received covered in oil & dirt

IPS performed electrical testing on the PowerSeal stator windings that were covered in oil and dirt; and achieved initial readings exceeding industry established standards, indicating that the winding insulation was not damaged. IPS repaired both sleeve bearings and machined four new oil rings and labyrinth seals in-house. We also worked with customer engineers to adjust pressure in the bearing housing to prevent oil from being sucked out of the bearing housings by connecting an air hose to the baffle.

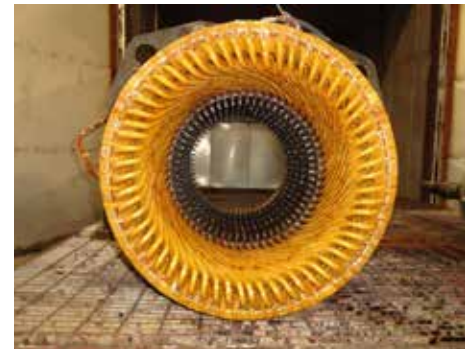
After: PowerSeal windings after cleaning are like new
